SECURITY SURVEY & RISK ASSESSMENT

UN HOUSE/UN COMMON PREMISES/ UNDP PREMISES

[DUTY STATION] – [COUNTRY]

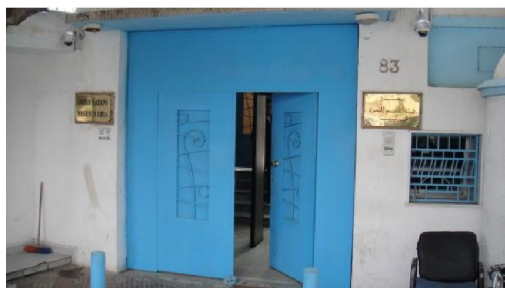
FIG.4 –Main Entrance (#1 in Fig.3)

Three locations access UN House from the surrounding streets. The double-sided main gate (fig.4) is accessible from XYZ street. It is used for all purposes: staff, visitors and goods. The sliding side gate (fig.5) is rarely used. On occasions it is used by tradesmen and for large deliveries. The sliding car parking gate (fig.6) is only used in the morning to let the UNDP office cars out and again at the end of the working day for overnight parking. All those gates are made of double-sided steel sheets.

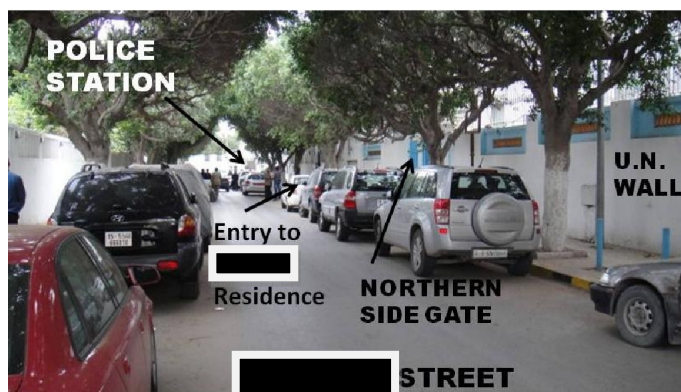
FIG.7 –View from XYZ Street

All the streets surrounding the UN-House are one-way traffic (see fig.2). Photos (fig.7, 8 & 9) show the

street perimeter wall and give an indication on the on-street parking around the premises. The parking by the perimeter wall is reserved for the UN staff members. Blue UN-marked signs are placed by the side-walk. However, this parking restriction is not enforced by the traffic police.

Although not sufficient to cope with the UN capacity, parking by the perimeter wall is reserved for UN official and staff private vehicles. Since the UN has no compulsion mechanism to stop infringement to this arrangement, government interference is needed. UNDP should approach the Municipality to: 1) increase the parking spaces reserved outside for the United Nations, and, 2) to instruct the traffic police in the square outside UN House to enforce the parking arrangement outside the UN House.

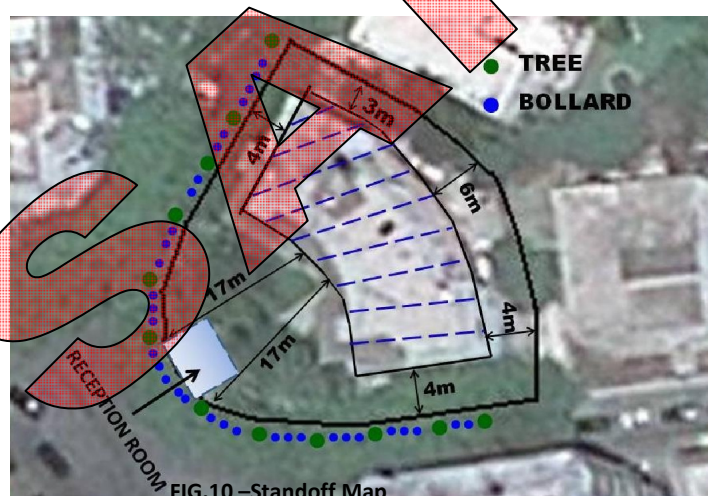
Note: All the quoted numbers in fig.10 are distances from the building external walls to the perimeter wall. Standoff is increased by the surrounding trees with the bollards introduced on the footpath by UNDP. Practically, all quoted distances should be increased by 2meters.

The standoff distance from GHI street is a good 17m to the perimeter wall. Neighbors' standoff ranges

from zero at the northern tip of the land (where the drivers' room is located wall to wall with the XYZ Residence) to 6m; with distances ranging between 3m to 4m in between. The standoff from the two side streets is only 4m to the main building but only 2m where UNCDF is located on the ABC street side of the building.

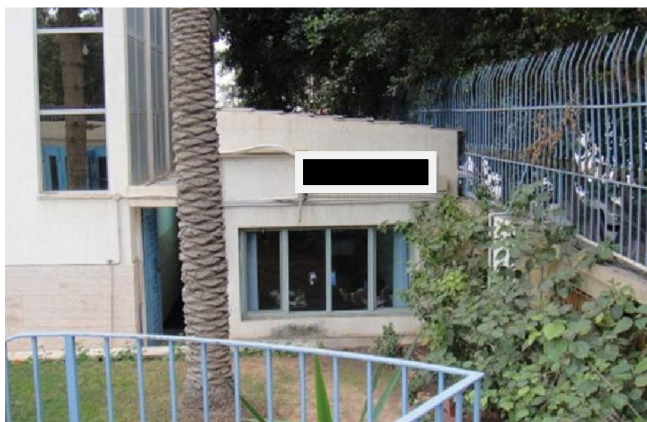
ABC street side/UNCDF: A structure was built between the building external wall and the perimeter wall. A cement roof was constructed and overlaid with brick tiles. This structure is along the ABC street side of the building wall and accommodates four UNCDF staff: two international and two local. Fig. 13 and 14 below explain the above.

FIG.13 –UNCDF office sunk under the garden and the street levels

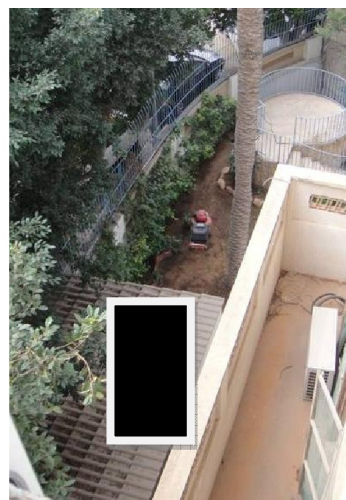
FIG.14 – A Top View of UNCDF

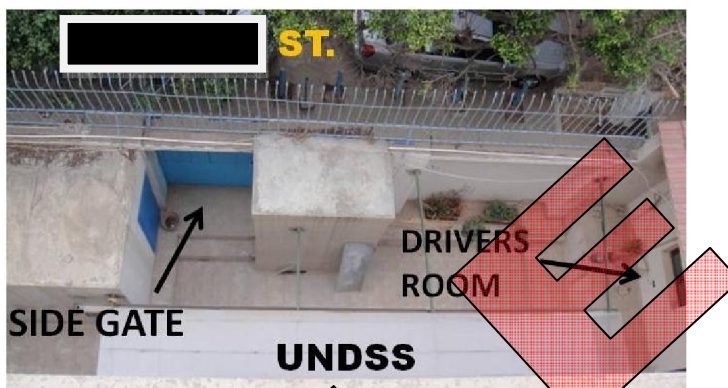
DEF street side/ UNDSS and Drivers' Room: UNDSS is located on the DEF side of the basement. Entrance can be achieved from outside the premises as shown in fig. 12 &15 or from inside the

building. The drivers' room was erected separately and external to the building. It is built wall to wall with the DEF street perimeter wall (fig.16) and the perimeter fence of the XYZ Ambassador's Residence. The standoff on the DEF street side is 4m.

FIG.16 –Same Side as Fig.15 showing Entrance to UNDSS and Drivers' Room

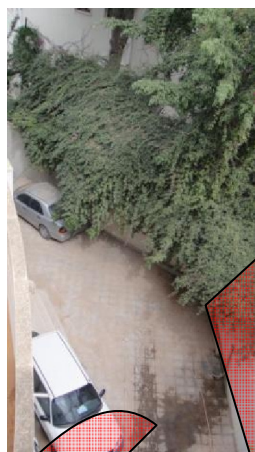
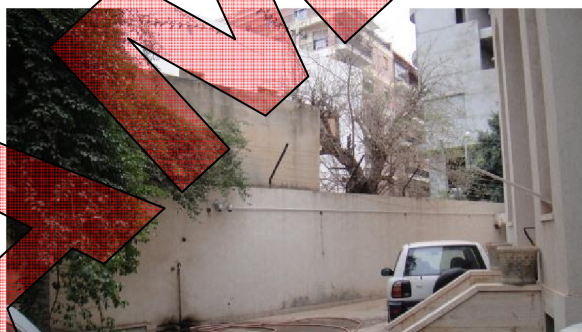
The car park area is located in the rear of the building. Accessed from GHI Street, it can accommodate up to 8 vehicles. Standoff on this side ranges from 3m to 6m. The perimeter wall on this side is approximately 3m high.

FIG.17 –Rear Parking area

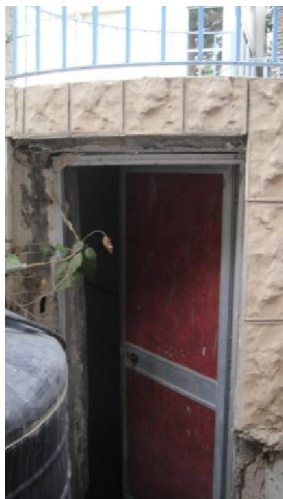
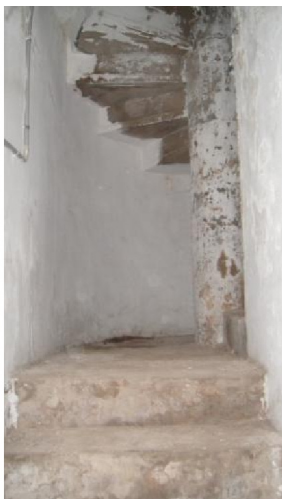
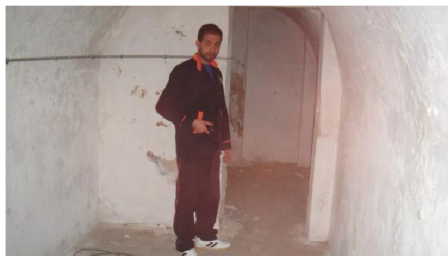
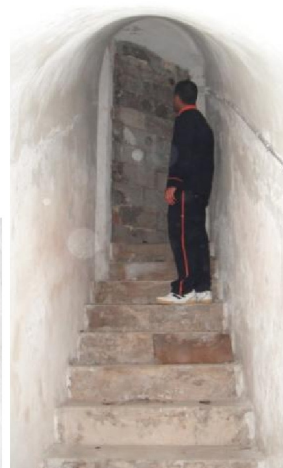
At the far edge of the front garden and behind the front reception area (see fig.11) a door leads to a circular staircase that descends below street level. At the base of the staircase, there is a path that leads, in series, to two very small rooms. Immediately after, few steps ascend again to the street level. A brick wall was built at the top of these steps to block the exit from this tunnel or shelter. It is believed that this tunnel was built as a shelter with an external escape route.

UNDP should keep the underground tunnel-passage-shelter, which can be accessed from the

garden, clear and clean for emergency use. Normal lighting and emergency lighting should be provided to this shelter. UNDP should also look at the possibility of opening the originally designed exit door and see how best it can be utilized.

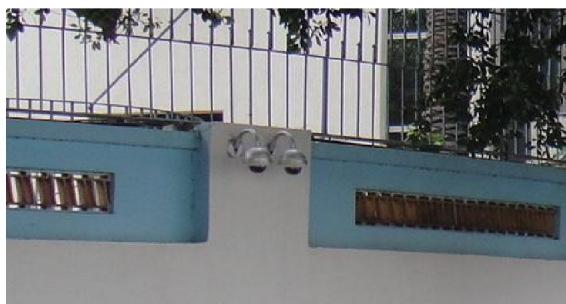
The CCTV system still needs improvement in multiplex display switching and recording capability. The multiplex improvement could be done in software expansion but the recording capability from 4 days to the recommended 30 days needs a bigger hard disk than the installed 1 Terabite.

FIG.26 – Typical installation of CCTV external camera

- c. More cameras are needed to be added to the system: One to cover the roof and roof door; one to cover the staircase accessing the roof; two cameras to be installed on the ground floor and two on the first floor to cover corridor areas.

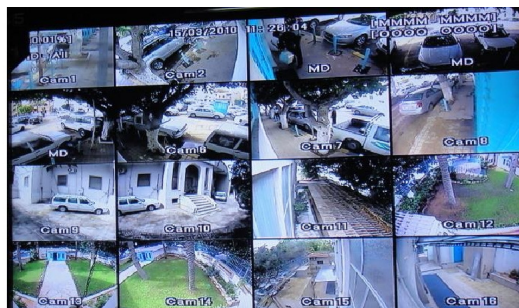
FIG.27 – Multiplex View in the IT room and also in the Receptionist room

- a. Monitoring at present is only accomplished inside the IT room and in the reception area. Both areas do not provide sufficient monitoring of the existing cameras. It is recommended that an additional monitor be placed to be viewed and controlled by a responsible UNDP person.

- b. The switching between the 16 multiplexed viewing can only be achieved manually at present. It is recommended that the necessary software/hardware be procured to enable automatic switching between the two multiplexed views.

- d. Currently, storage of recorded archive is insufficient. Only 1 Terabite of storage is available to give 4 days of recording. This needs to be increased to Four Terabite of hard disc storage to enable archiving for 30 days.

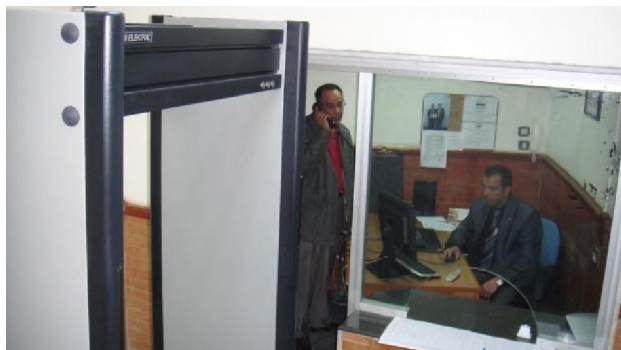
FIG.28 – The Reception Room

- b. Receptionist/Telephone Operator (fig.28): the receptionist is hired by UNDP with a security element in his TOR. The telephone switchboard is located on the receptionist's desk. The receptionist also performs the duty of the telephone operator (seen in fig.28 above)

Reception Area/Room: This area needs expansion and re-design. After allowing the visitor inside the main gate, he/she should undergo security checks, for bags and body, by a UN-contracted security guard. After this, the visitor proceeds to the receptionist for registration and issue of visitor's ID card. Then, the receptionist opens (electronically) the inner reception door to allow the visitor inside the premises after the arrival of the escort staff members. All visitors must be escorted into the premises. The diagram to the right should give a fair indication to the needed procedure in the reception area.

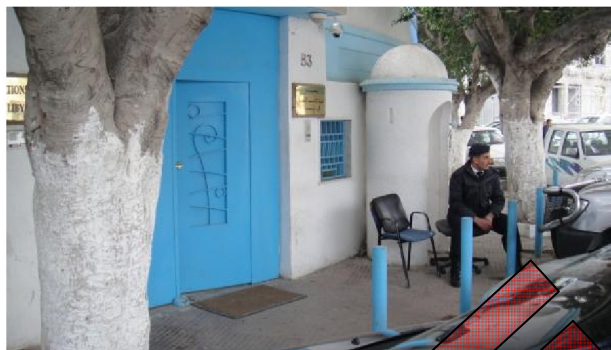
FIG.29 – Receptionist window shown by the Police Guard

- d. Access Control Measures: Visitors access control procedures are seldom adhered to. The window in the reception room (fig.29), made especially for communications between the visitors and the receptionist, is rarely used. The interphone fitted for the same purpose by the window is also not utilized the way it should. When appearing on the CCTV monitor, the visitor is allowed accessed into the reception area. As previously mentioned, the walk-through metal detector is rarely utilized and bags are rarely searched.

Access Control of Visitors: Non-UN staff should not be allowed inside the front gate without having the purpose of their visit checked first by the receptionist. All verbal communications with the visitor should be done while he/she is outside the premises □ main gate: either through the window or through the interphone. Once inside the front gate, a dedicated access control security guard should clear the visitor, physically check bags and request the visitor to walk-through the metal detector for further checking
