**UNITED NATIONS DEVELOPMENT PROGRAMME [COUNTRY]**  
**SECURITY RISK ASSESSMENT & RECOMMENDED MITIGATION MEASURES**  
**FOR**  
**THE [OFFICE] IN [DUTY STATION] – [COUNTRY]**

**DATE OF SURVEY: [DAY-MONTH-YEAR]**

**DATE OF REPORT: [DAY-MONTH-YEAR]**

**REPORT BY: [NAME UN SECURITY ADVISOR UNDSS]**

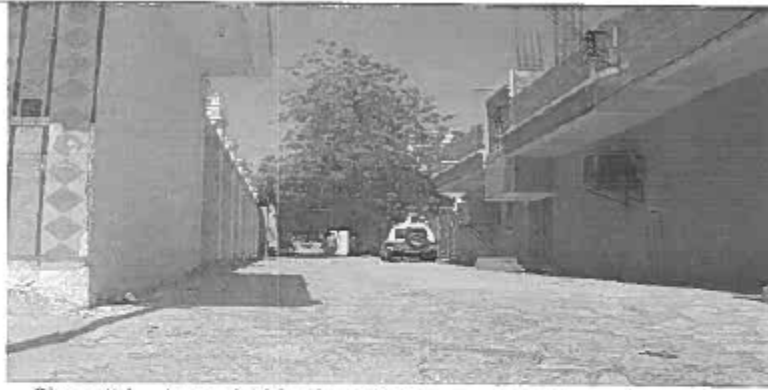
- Stand-off Distance (SOD) between the main street (ABC Street) and the main entrance of the office is xxx meters. (Photo #1)
- From the South: A private residence located at the southern site of the office, a 3-meter high wall separates the office from the neighborhood, while there is insufficient SOD to the southern rear area and the neighboring house. (Photo #2)

Photo # 1 - Around 100 meter SOD to road and the main entrance

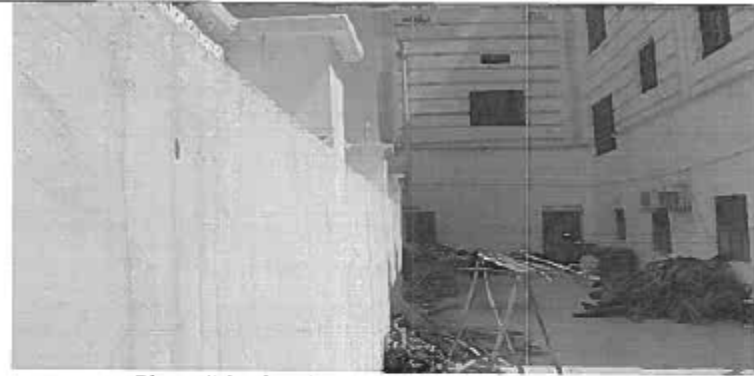
Photo # 2 - Southern - the rear of the building

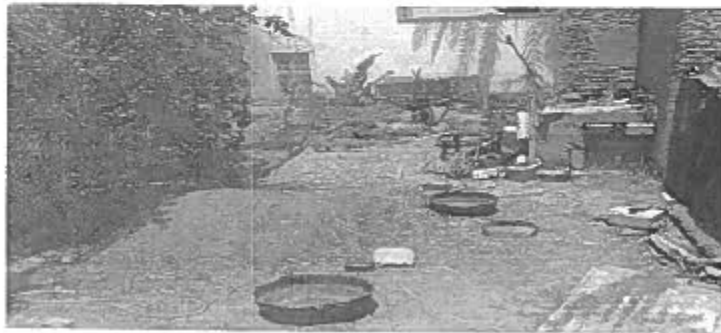
- From the East: the eastern area of the building is divided into 2 parts, at the rear part there is a small piece of land - sufficient SOD - to south east side of the building and northern side of the neighboring house (Photo #3), a 3-meter high wall separates the office from the plot of land. (Photo #4), emergency exit door (Photo #5).

Photo# 3 – piece of land between the building and the eastern neighbor

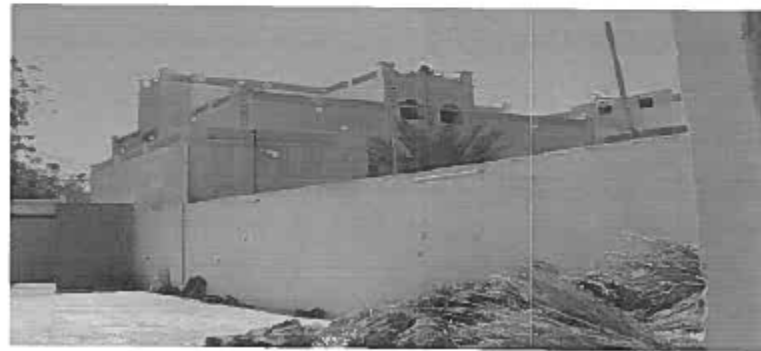
Photo # 4 - the second part of the Western

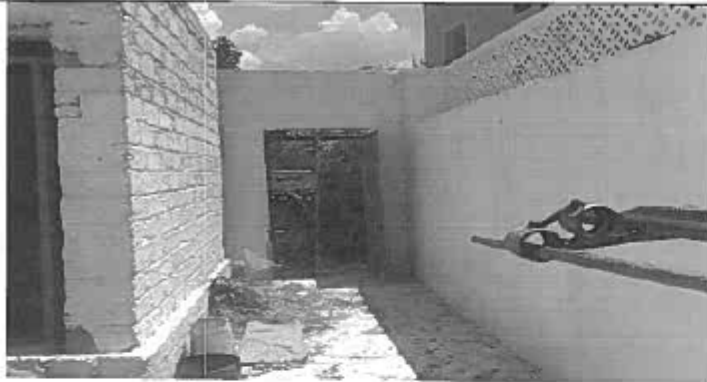
Photo # 5 - Emergency Exit ( East)

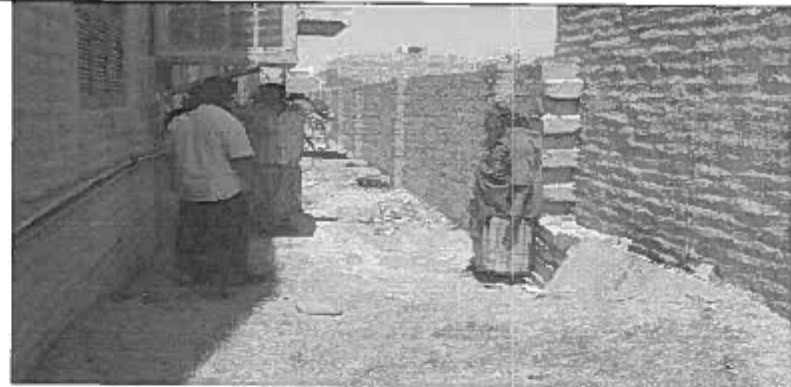
- From the West: there is insufficient SOD to the side of the building and a 1.5-meter high wall, separates the building from the adjacent empty plot of land. Therefore, there is sufficient SOD between the wall and the main western road, (Photos # 6 & 7).

Photo #6 – the western wall perimeter - HESCO required

17. Razor wire to be installed on top of the perimeter walls, including the partitions between the neighbors dwelling and the office
18. Shatter Resistant Film (SRF) should be applied to all window/partition glass surfaces
19. Window Security Grills are required on all 'lower level' windows
20. A HESCO bastion wall should reinforce the inside of the western perimeter wall. (Please see Photo #6)

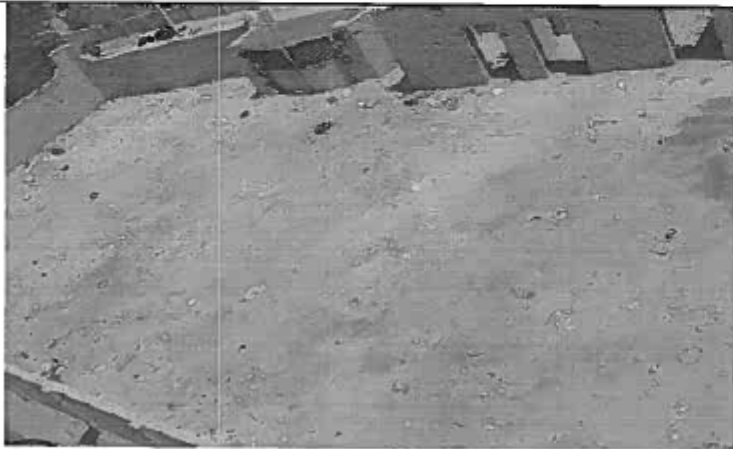
Photo #7 – an empty piece of land at the western side of the office – view at the western road.

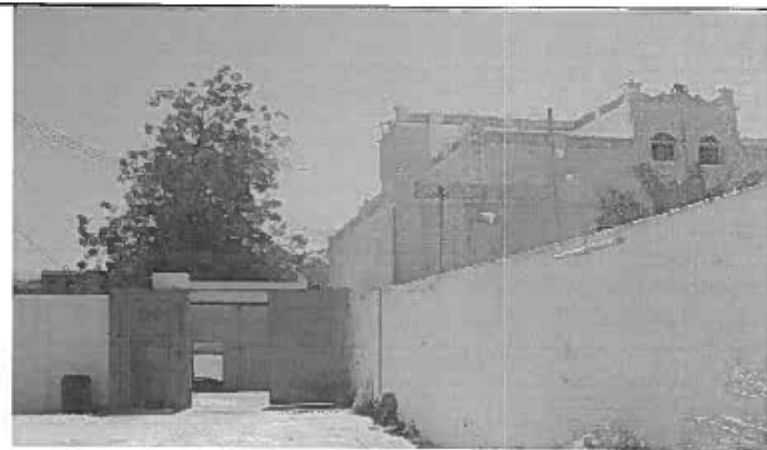
- e) There are 2 metal doors at the main entrance (Photo # 8).
- f) There is a CCTV/Security camera system that satisfactory covers the front left/rights and rear sides of the building.

Photo # 8 - two steel gates at the main entrance

5. The main entrance gate of the office should be replaced/reinforced with solid steel. Two pylons should be installed at each side of the main gate to further reinforce the gate anti-ram capability

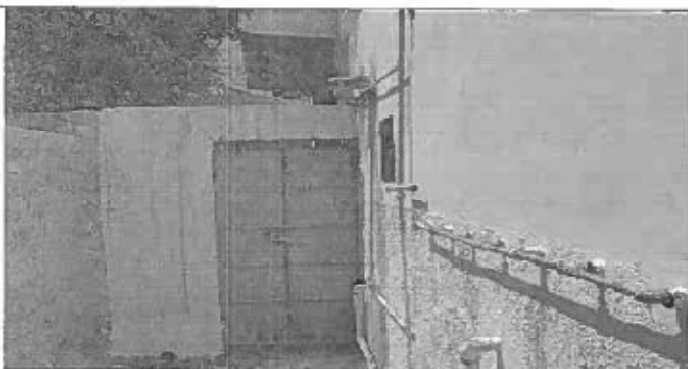
Photo # 9 – the main door at the right side of the main entrance to the building be used as staff and visitors entrance/exit at the daily bases and this will lead to the access control room (photo # 11)

6. The main entrance door located at the right side of the main gate to be used as access control; electronic access control system should be installed

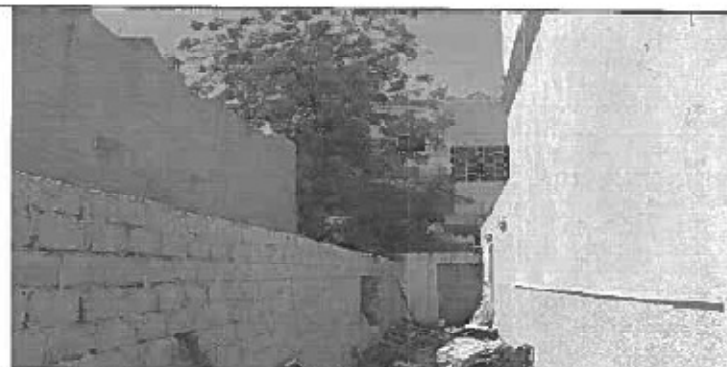
Photo # 10 - The premiter wall is located at front (northern side) of the bulding – to be rised up to 3 miters

Note 1: The owner promised to rise of the concrete 1.5-meter high wall to 3 meters.

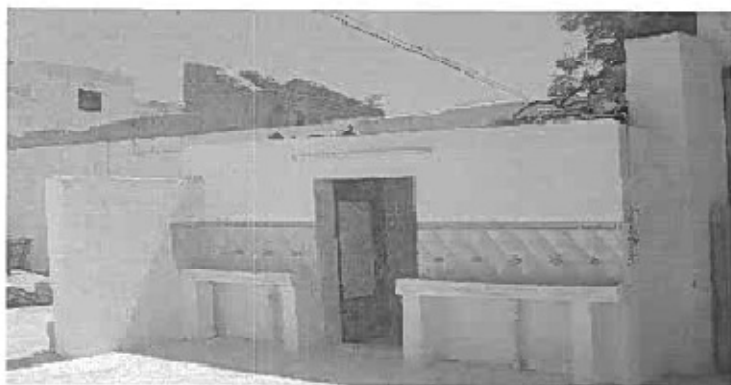
Photo # 11 - Rest rooms at the main entrance – need to be rebuilt to be used as access control room, there is no other ulternative.

3. Access control: Proper reception and inspection room to be established; screening procedures to be drafted and strictly implemented
4. Handheld metal detectors and inspection mirrors are mandatory for the guard-force at the accesses control
