SECURITY SURVEY & RISK ASSESSMENT

UN HOUSE/UN COMMON PREMISES/ UNDP PREMISES

[DUTY STATION] – [COUNTRY]

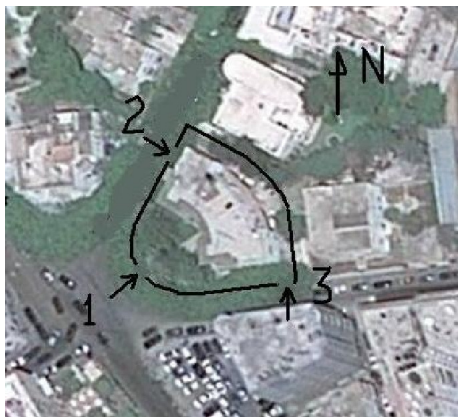
Second Floor/Roof: This floor has four rooms and a service area. One of the rooms is used as the WFP Liaison Office in Duty Station X, housing one local staff member. The rest of the floor is the open roof area. Car Parking Area: is situated towards the rear of the building with access from the side street (marked as 3 on Fig.3 below).

FIG.3 – No.1. Main Entrance,
No.2. Side Gate (service gate)
No.3. Car Park entrance

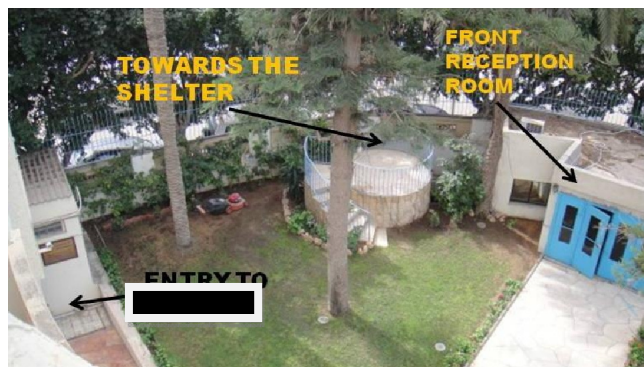
The front loan area is an elevated ground ranging from 1.5m to 1.8m above street level. Walking towards UNIDO and UNDSS, one has to take few steps down descending to about 0.5m below street level. This is the floor level of UNIDO and UNDSS. The rest of the basement is approximately 1m below the street level.

FIG.11 –Front Garden left side showing entrance to UNIDO

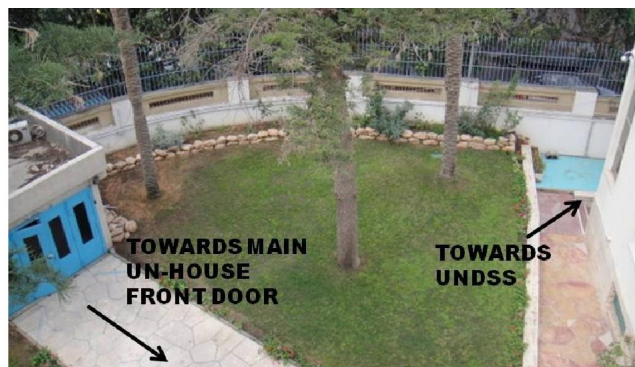
FIG.12 – Front Garden right side showing way to UNDSS and the drivers' room

DEF street side/ UNDSS and Drivers' Room: UNDSS is located on the DEF side of the basement. Entrance can be achieved from outside the premises as shown in fig. 12 &15 or from inside the

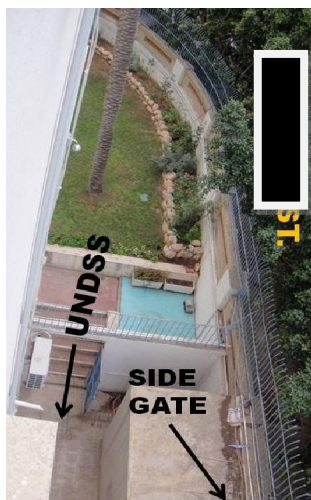
building. The drivers' room was erected separately and external to the building. It is built wall to wall with the DEF street perimeter wall (fig.16) and the perimeter fence of the XYZ Ambassador's Residence. The standoff on the DEF street side is 4m.

FIG.15 – DEF St. Side of the Building

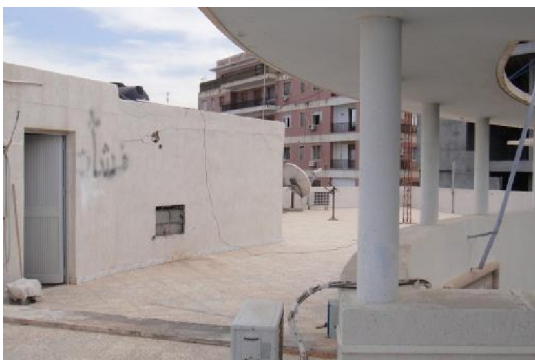
The second floor is the roof level. Four rooms and service area has been built on this last floor of the building. The FAO Liaison Office has taken an office room there. The exposed roof is a clear area with satellite dishes and an old communications mast.

FIG.23 – The Roof Area

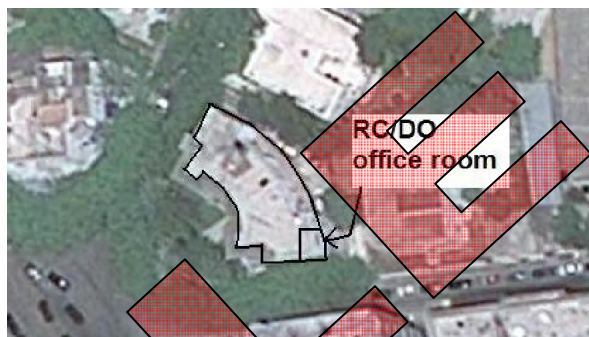
This office is located on the first floor at the south-eastern corner of the first floor by DEF street. This means it has a standoff of $4+1.5=5.5$ meters from the street plus the added elevation.

FIG.25 – Building layout showing RC/DO office on 1st floor
